**UPPER MISSISSIPPI RIVER SYSTEM
ENVIRONMENTAL MANAGEMENT PROGRAM
POST-CONSTRUCTION INITIAL PERFORMANCE
EVALUATION REPORT (IPER4F)**

**BAY ISLAND HABITAT REHABILITATION
AND ENHANCEMENT PROJECT**

DECEMBER 1999

· **POOL 22**
MISSISSIPPI RIVER MILES 311-312
MARION COUNTY, MISSOURI

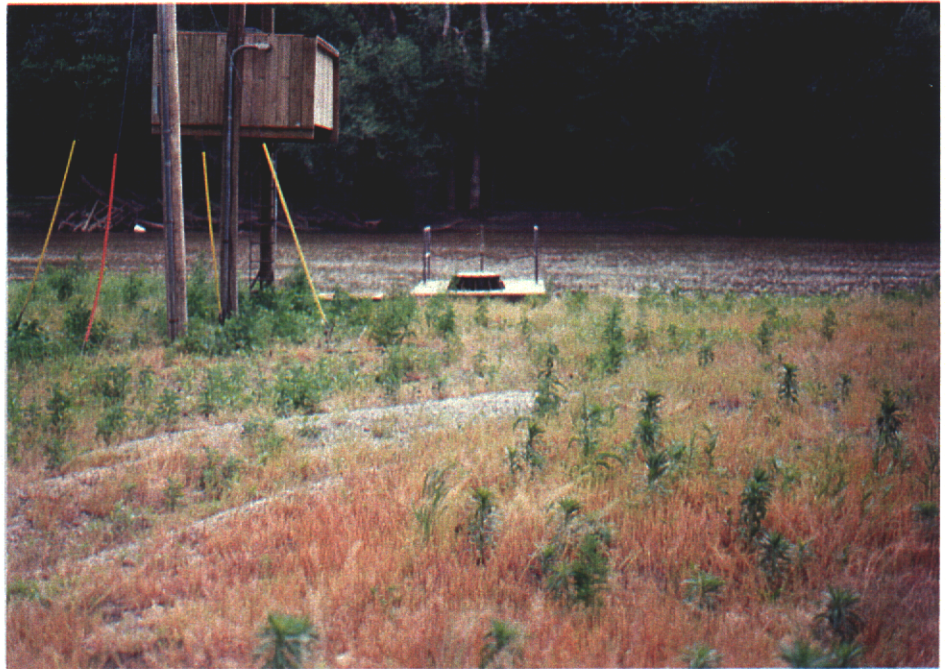
(b) Pump Station. The pump station consists of a 6,000-gpm submersible propeller-type pump. This pump has the capacity to fill in the NWMU in 15 days and both units in 23 days. The pump station, located on the south end of the project, pumps water from Ziegler Chute. The pump is housed in a vandal-resistant cast-in-place building. The intake entrance is equipped with a trash rack. Underground single-phase electrical power is provided to the site. All necessary electrical equipment is located on an overhead platform (see photos 1 and 2, page 13).

Photo 1. Pump station and electrical control equipment platform.

(x) Structure - wood	Ok-wobbly-poor design
(x) Displaced/missing riprap	Some erosion at outlet pipe
(x) Electrical controls	Questionable -see comments
(x) Steel discharge pipe/flapgate	Ok

Leaf and debris buildup on intake grate during pumping operations blamed for pump shutting off this fall - due to excessive water flow restrictions which causes float to shut pump down.

(b) Actions and Recommendations. Construct a slide gate on the outside of the pump station intake structure and build a platform structure in the pumping chamber. The slide gate will be placed at the intake of the pump station near the existing trash rack. It will be closed during non-pumping times to prevent the buildup of silt in the pumping chamber. Without the buildup of silt, the phase converter should no longer have a problem of being thrown out of balance. A platform with a ladder will be installed to facilitate cleaning out of any silt that collects inside the pumping chamber. Information on air-lift pumps will be forwarded to the MDOC.

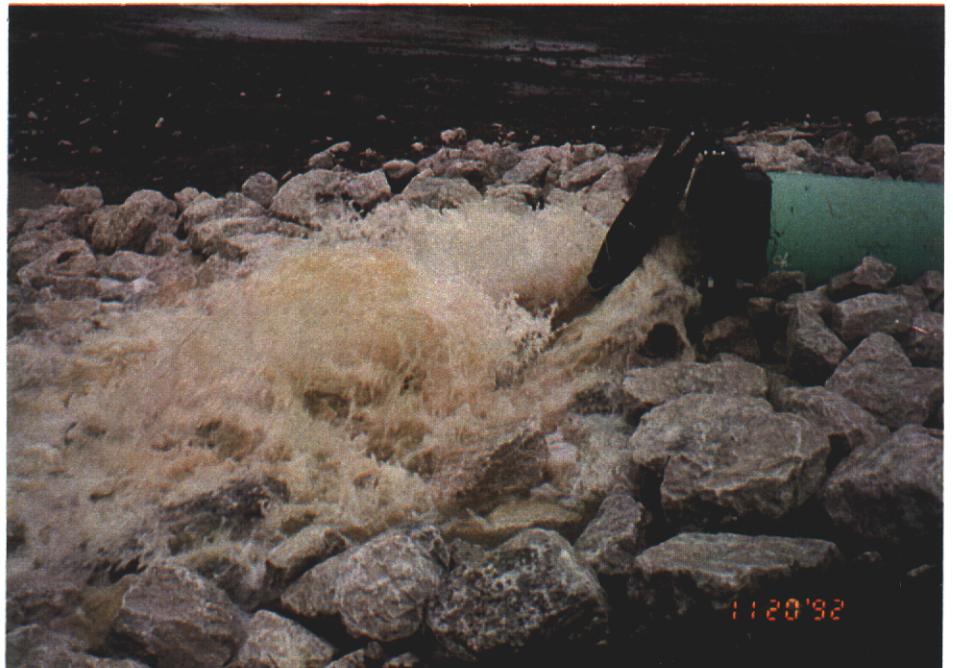
Photo 2. Pump station outfall.

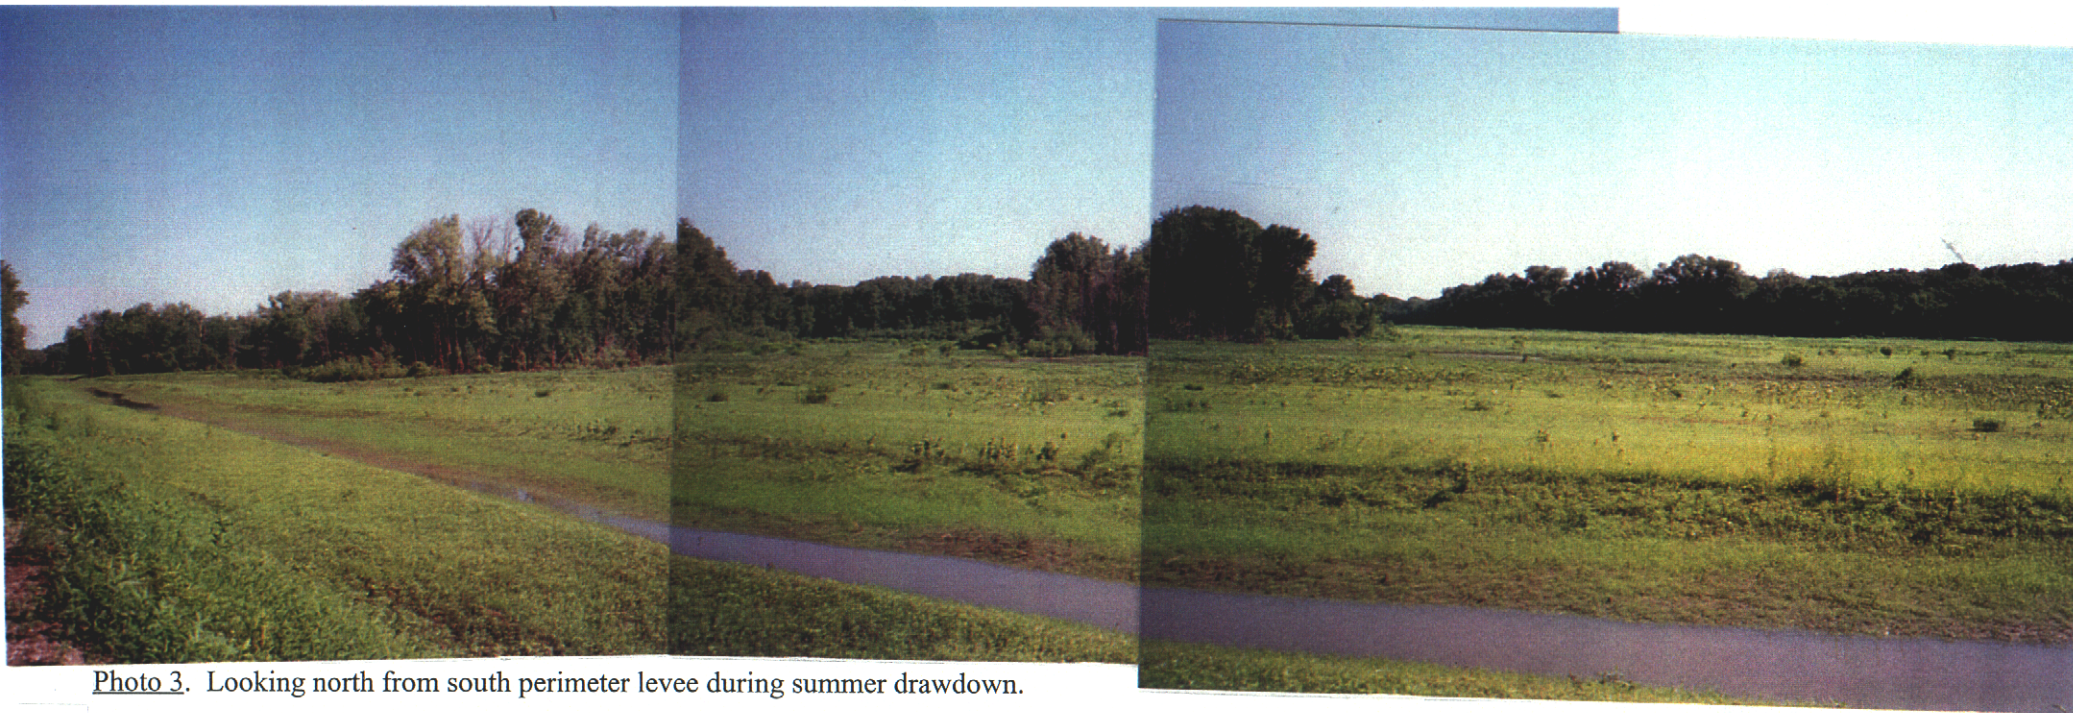
(a) Perimeter Levee. The 19,194-foot-long perimeter levee provides at least a 2-year level of flood protection. The levee has a 10- to 12-foot crown with 4H:1V side slopes. An intermediate levee subdivides the area enclosed by the perimeter levee, creating two WMUs, a north and a south unit, NWMU and SWMU, respectively (see photos 3 and 4, page 14).

Photo 3. Looking north from south perimeter levee during summer drawdown.

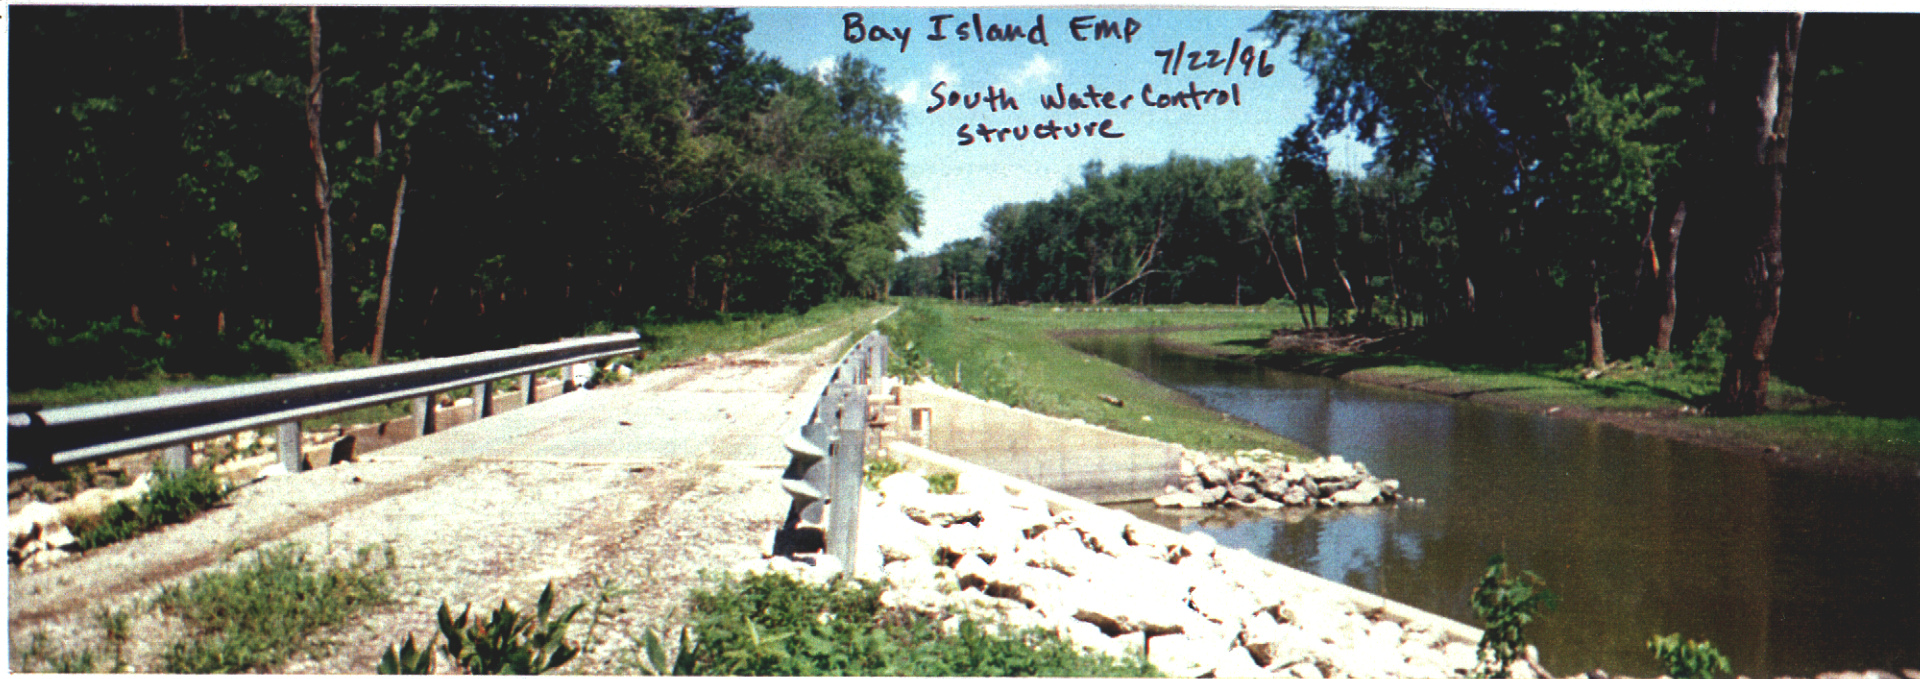
Photo 4. Perimeter levee and south water control structure.

(b) Actions and Recommendations. Grade remaining levee slope and place a layer of riprap. The riprap will be well graded so that a bedding layer will not be required. The riprap layer will be placed 6 feet off the edge of levee crown and run down to the base of the levee toe for the stretch of levee where erosion is evident.

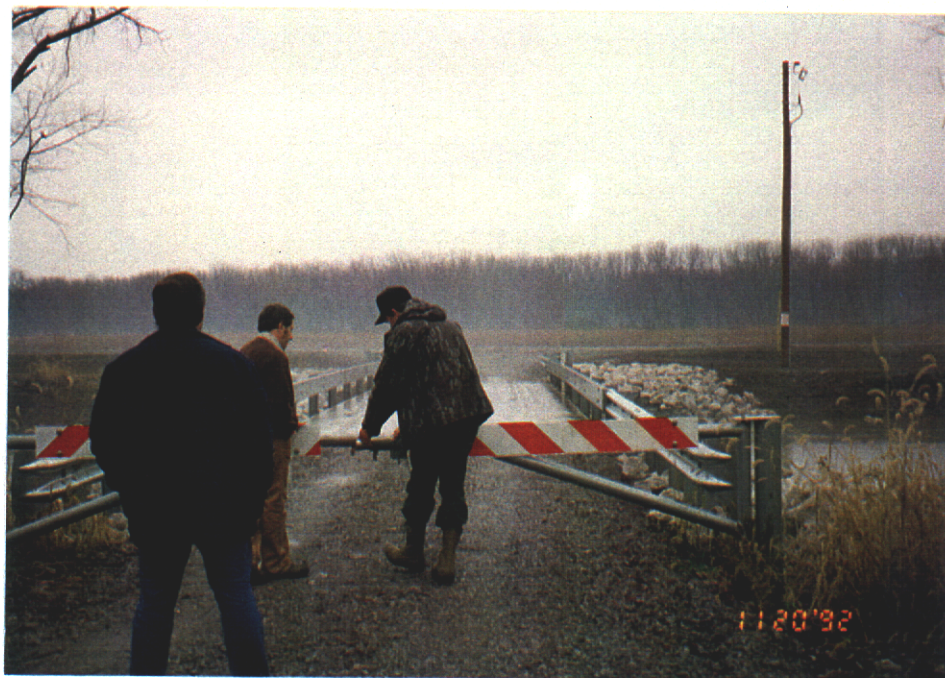
A new prefabricated deck bridge with concrete abutments provides project access over Clear Creek. The span length is 42 feet and the deck width is 15 feet. The bridge carries a

standard H20 loading designation. The bottom elevation of the bottom chord of the bridge is 464.4 MSL and was designed to allow passage of a 100-year flow of Clear Creek plus the drainage outflow from the South River Drainage District (see plate 2) with 1 foot of clearance (see photo 5, page 15).

Photo 5. Site access bridge.

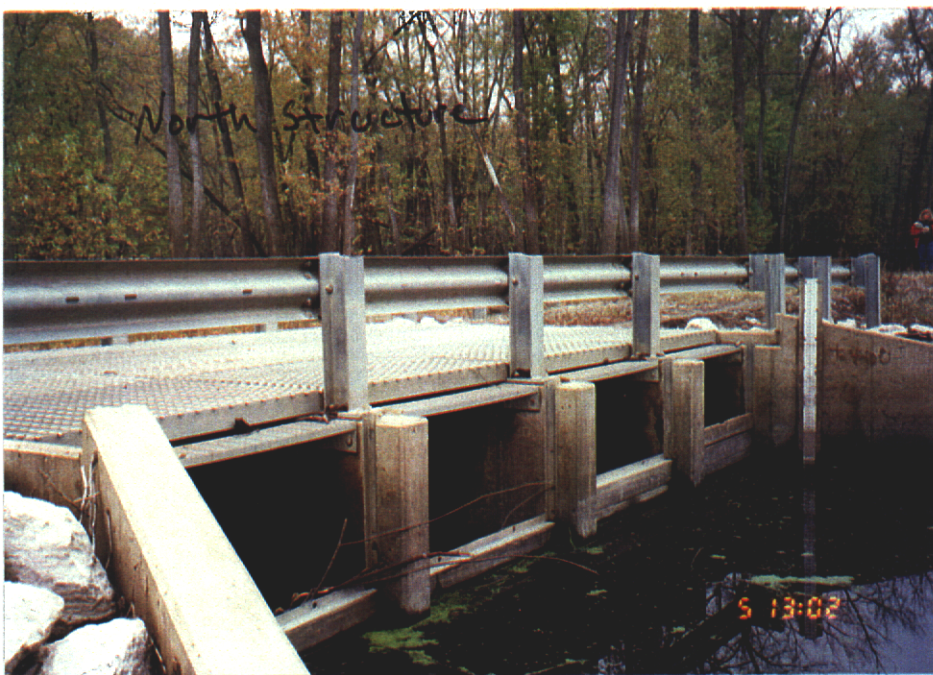
(c) Water Control Structures. The WMUs have three water control structures. Two water control structures, each having four 5-foot-wide stoplog bays, are located on the perimeter levee. The intermediate levee has one water control structure with two 3-foot-wide stoplog bays. Wood stoplogs are inserted into the control structure bays to establish water ponding elevations. The perimeter levee water control structures are sized to preclude the need for an armored levee overflow section. All of the water control structures have a steel grate deck to allow for vehicle passage overhead (see photos 6, 7 and 8, pages 15 and 16).

Photo 6. Perimeter water control structure with stop logs in place.

c. Water Control Structures. Recommend consideration be given to the added benefit of establishing a higher level of protection and including overflow spillways into the levee system. Overflow spillways take the burden off of the local sponsors to open closure structures in a timely fashion. Any stoplog structures built in conjunction with future projects should be designed and constructed to allow easy removal and installation of the stop logs by one person.

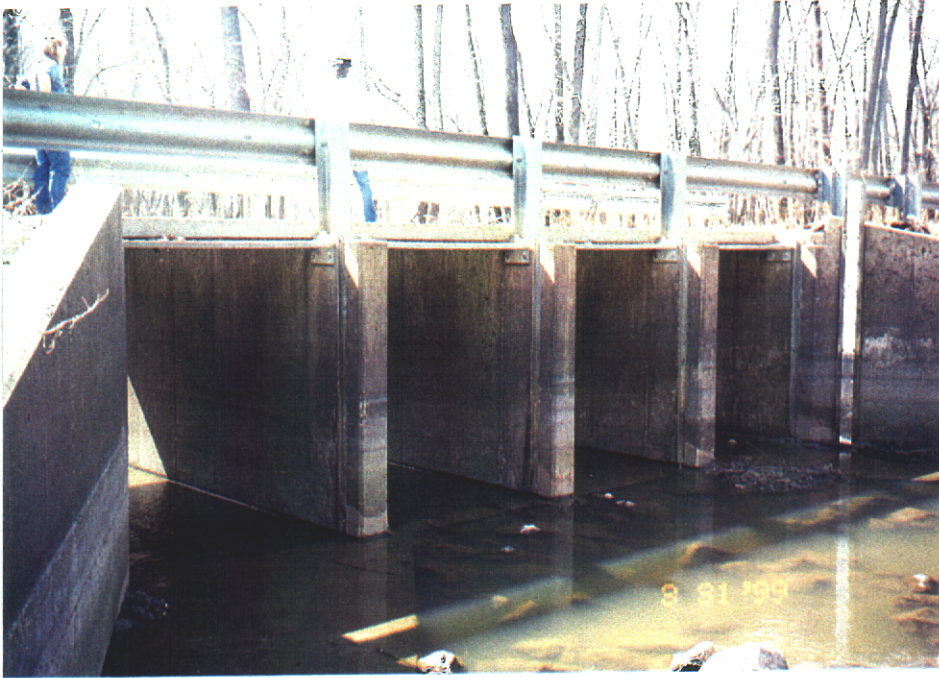
Photo 7. Perimeter water control structure with stop logs removed.

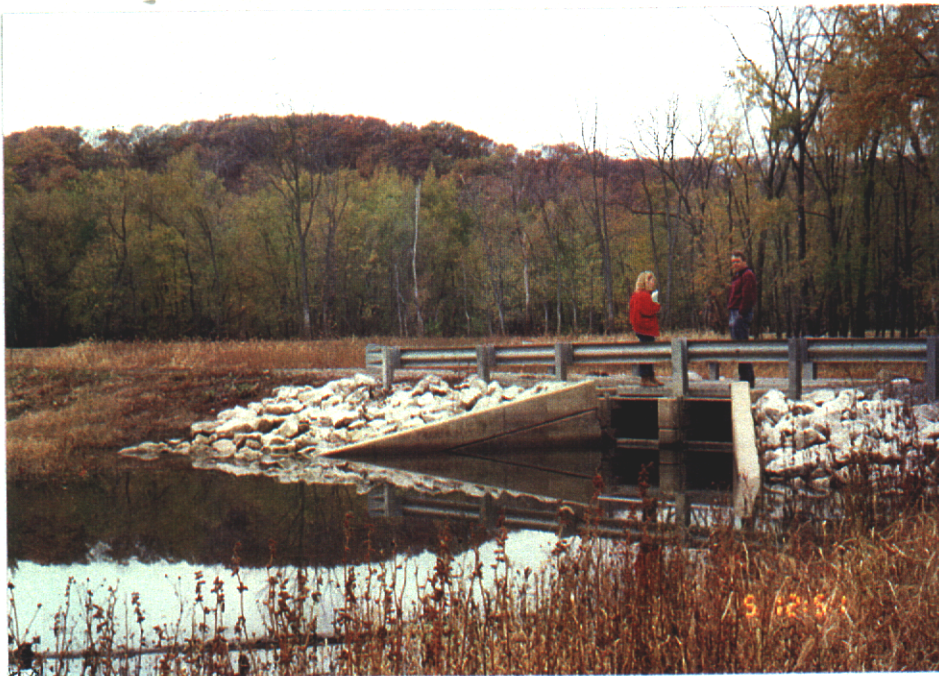
Photo 8. Intermediate (interior) water control structure (2-bay stop logs)

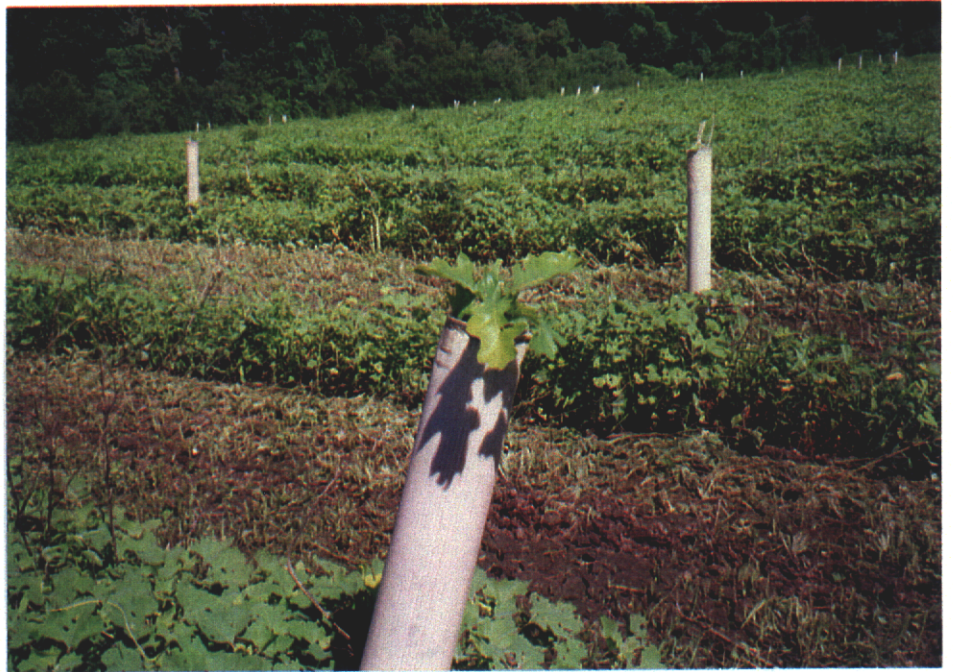
(a) Challenges or Difficulties. Minimal to no success was achieved from the planting of tree seedlings and acorns at Bay Island. Some of the failure can be attributed to the major flooding of this site since project completion. Planting areas have been unable to compete with other vegetation. Apparently, the plantings were too close together and not adequately marked for MDOC's mowers to navigate around, and seedlings and acorn plantings were difficult to locate once competing vegetation had grown up. Seedlings that had plastic tubes placed around them died as a result of being silted in during high water events.

Photo 9. Bare-root tree seedlings with tree shelter protection.

(b) Actions and Recommendations. Additional trees have been planted since the 1993 flood. More trees will be added to the project as funding allows in the areas where the seedlings and acorns failed to grow. Recommend that future plantings be larger stock trees. Spacing and marking of tree plantings should be more closely coordinated with the local sponsor.

d. Mast Tree Plantings. Recommend that future HREPs pursue more mast tree plantings that consist of container-grown or balled and burlapped trees. If seedlings or acorns are used, the layout should be coordinated with the local sponsor who will be maintaining the site to ensure that trees are clearly marked and appropriately spaced for the mowing equipment to be used at the site.

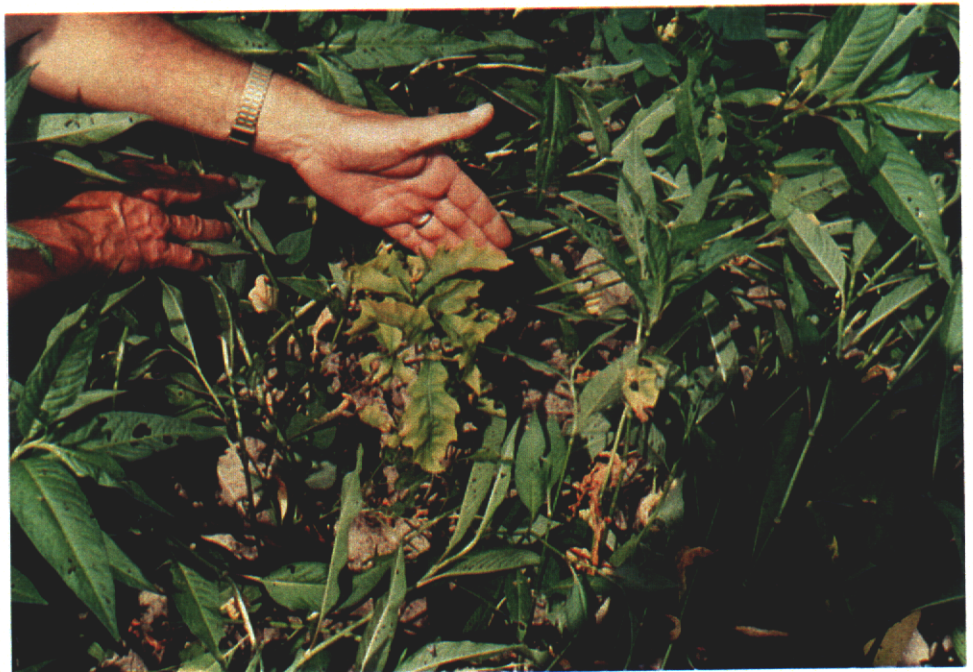
Photo 10. Seedling sprouted from acorn.

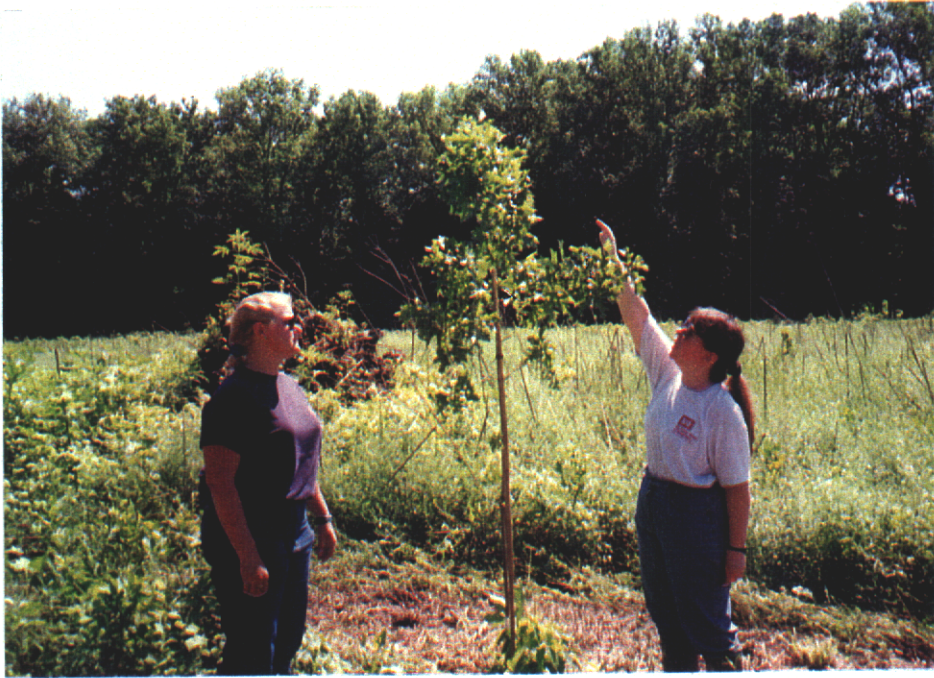
Photo 11. Container-grown tree stock.
